# 2019 Aldergrove Sanitary Sewer Infiltration and Inflow Reduction Project

ENGR 481, Spring 2019

2019 Aldergrove Sanitary Sewer Infiltration  
and Inflow Reduction Project  
Final Report

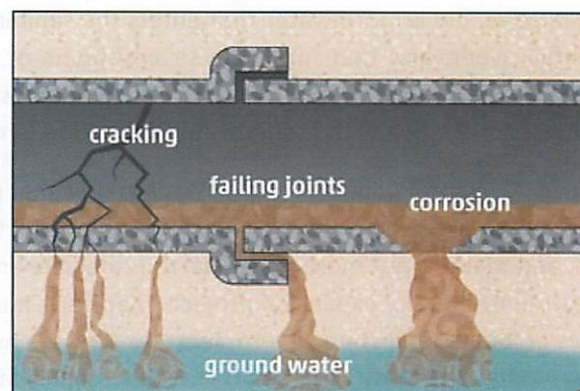
Figure 4. A depiction of potential causes and effects of exfiltration from sanitary sewers through defects (Bhatia 2017).

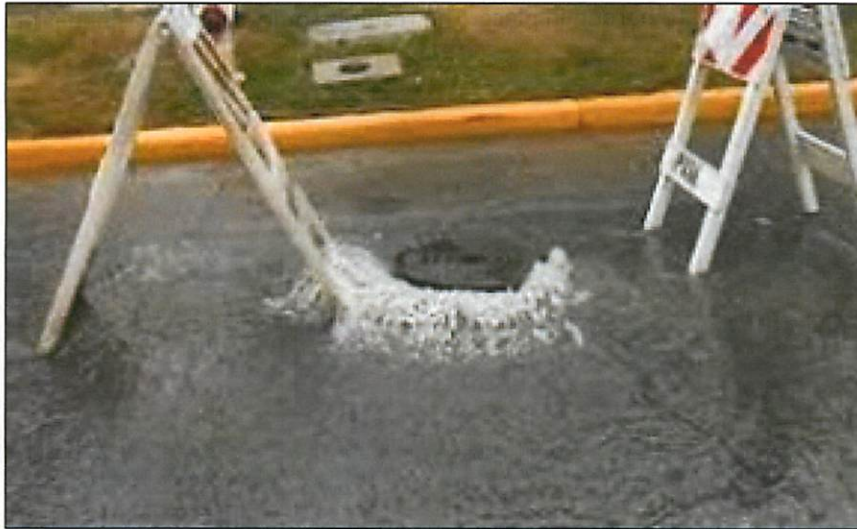
**Figure 5.** A sanitary sewer overflow occurring in Arcata (City of Arcata).

Excessive I&I can also result in surcharging of the sewer system, which can lead to sanitary sewer overflows; sanitary sewer overflows (SSOs) occur when a mixture of wastewater, infiltrated groundwater, and stormwater (inflow) surcharges and overflows manholes, leaving the sanitary sewer (such an even that occurred in Arcata is depicted in Figure 5) (EPA 1996).

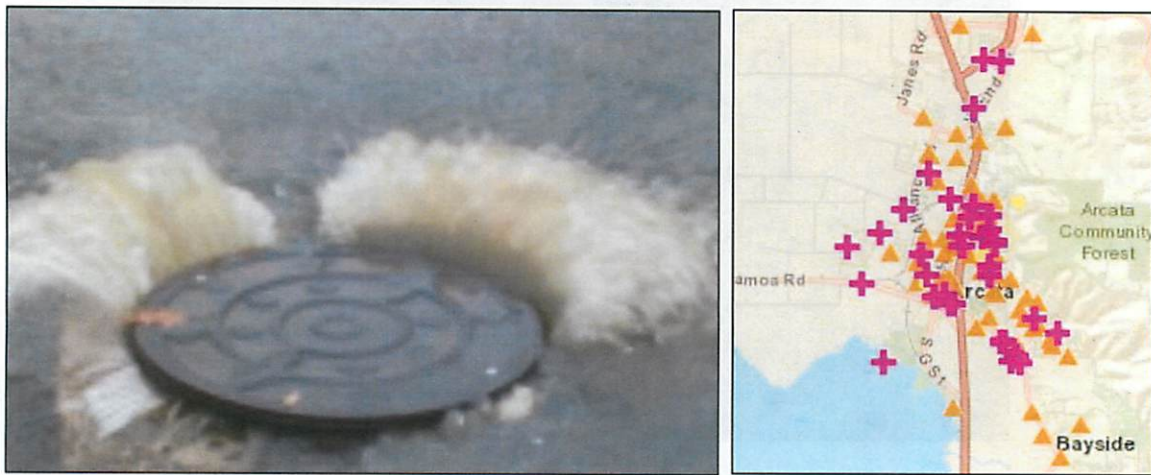
Figure 6. A sanitary sewer over flow in Arcata (left), and the locations of sanitary sewer overflow events in Arcata since 2007. The pink crosses indicate a category 1 overflow, which means the overflowed water reached surface water. The orange triangles indicate SSOs that did not result in surface-water contamination (CoA 2019c) (CA State Water Board 2019).

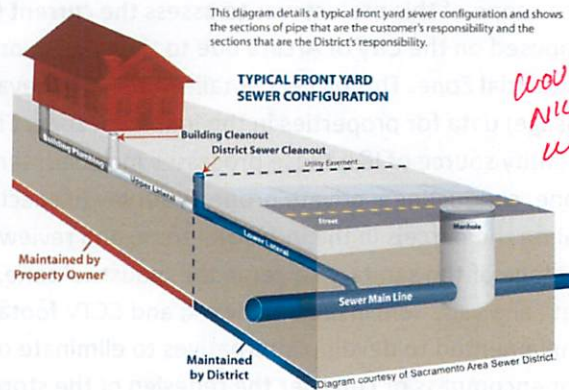
Figure 7. Typical lateral connection to the sanitary sewers in Arcata (CoA 2019b).

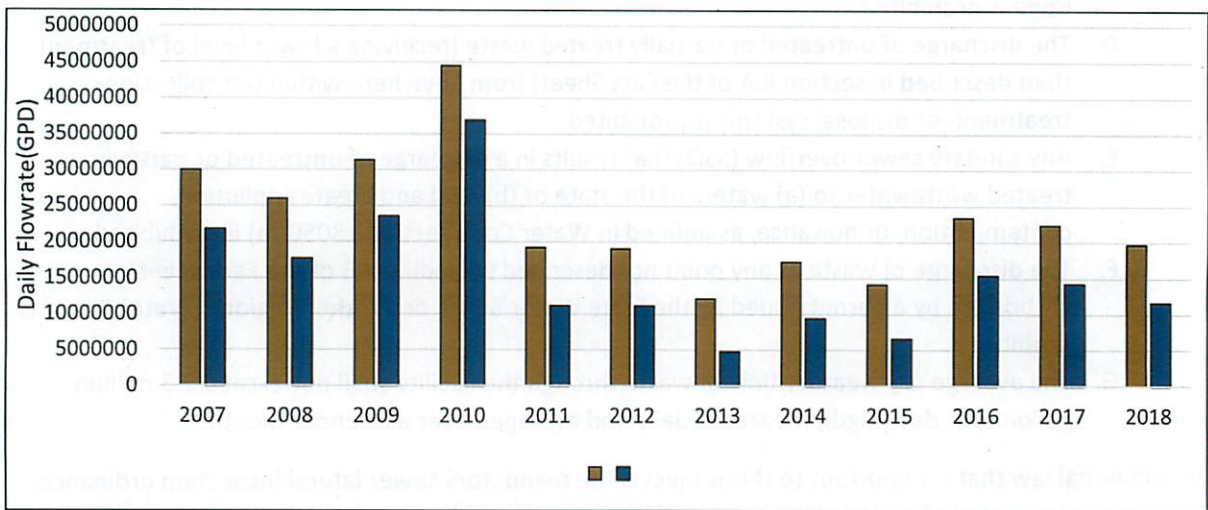
Figure 9. Average dry and wet weather daily total flow rates for the Aldergrove lift station for the years of 2010-2018.

Data analysis was conducted of available historical flow rate data from 2007 to 2018. Due to the fact that the average wet weather flows differ substantially for the years of 2007-2010 and 2011-2018 (roughly 13,000 vs 7,000 gallons per day wet weather flow) (magnitudes shown in Figure 9 below), data prior to 2011 was rejected from further analysis. An algorithm was developed to separate infiltration and inflow from total flow rate observations, given that the base sanitary flow rate was known. The base sanitary flowrate for 2018 was estimated as 100-percent of the total water consumed, which was determined from analysis of available water use data for the Aldergrove area (City of Arcata Finance Department, 2018 Water Use Data, 2019). The methodology behind the algorithm is not reported due to time constraints (please inquire if this information is desired). However, one thing to consider is that separating infiltration from flow rate observations is more of an art than a science (although educated estimates were made with reference to statistical findings). Figure 10 shows total daily flow rate and precipitation observations for 2018, and Figure 11 shows the results of the application of the algorithm to develop a flow rate profile for 2018. This algorithm was applied to each year (2011-2018) to determine the total annual volume of infiltration and inflow respectfully for each year (shown in Figure 12). Figure 13 and Figure 14 show the lift station pump operation times for 2017 over the course of the year and with respect to I&I volumes, respectfully. These figures show that direct inflow was the primary cause of long operation times and operations and maintenance costs. To estimate the conveyance and treatment costs associated with daily infiltration, inflow, and abuse sanitary flow rate observations, a scheme was developed using the EPA's suggested value conveyance and treatment cost for wastewater of \$2-\$5per 1000 gallons, where increasing flows resulted in higher costs being applied (direct inflow was penalized). Information on how this was conducted and underlying data is available upon request but was not reported here due to time constraints.

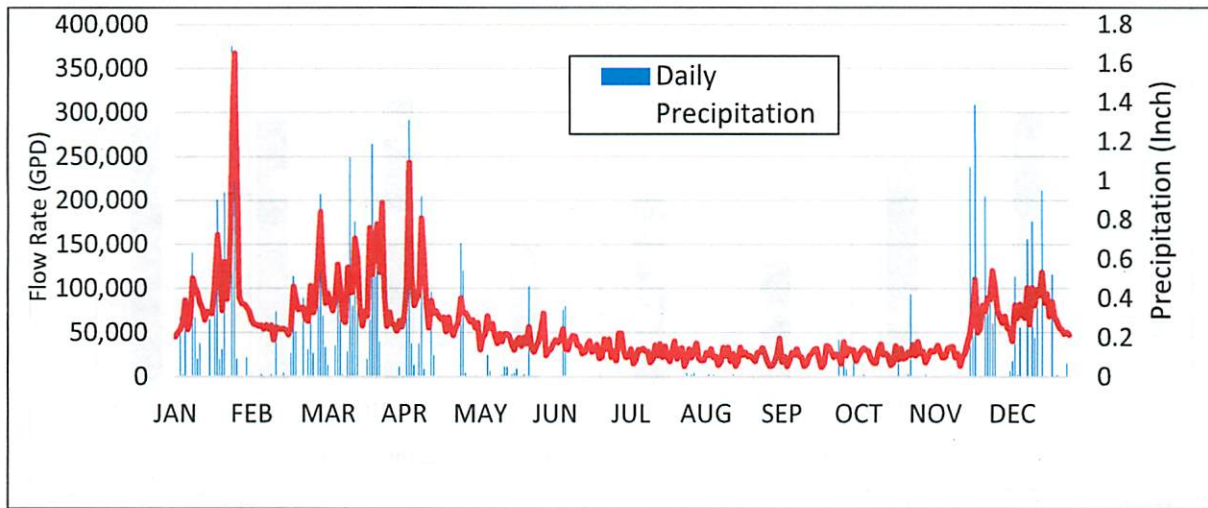
Figure 10. Total daily flow rate observations past the Aldergrove lift station in 2018.

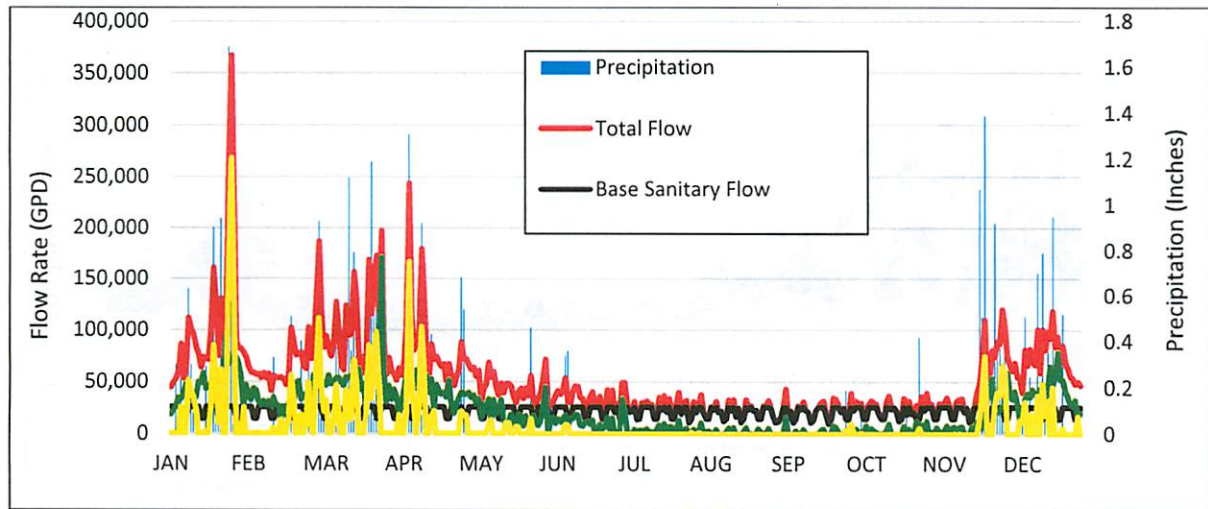
Figure 11. Results of the application of the developed algorithm to develop a flow rate profile for 2018.

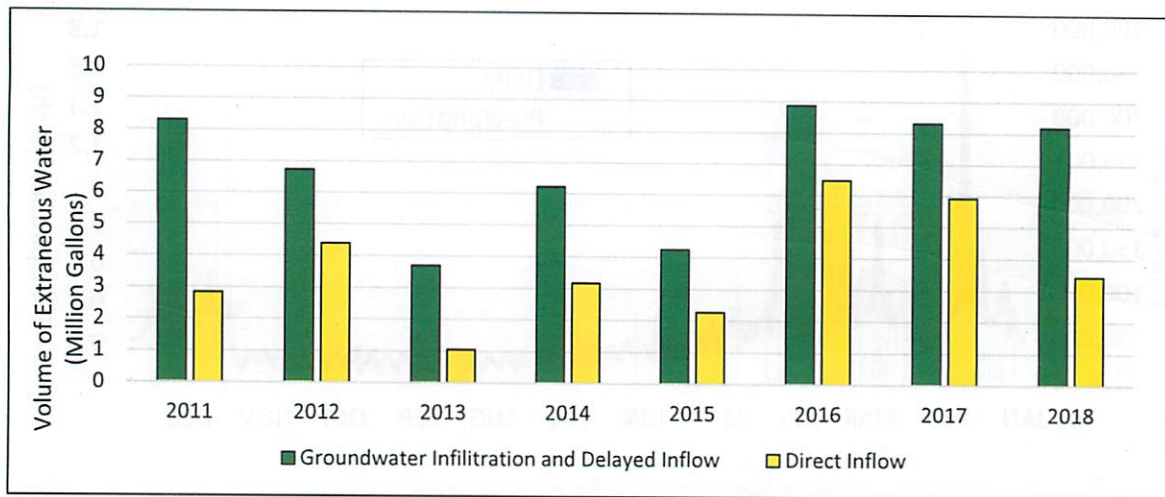
**Figure 12.** Total annual volume of infiltration and of inflow for the years 2011-2018. This was determined by developing a flow rate profile for each year (reported in the Appendix) and summing total flow observations.

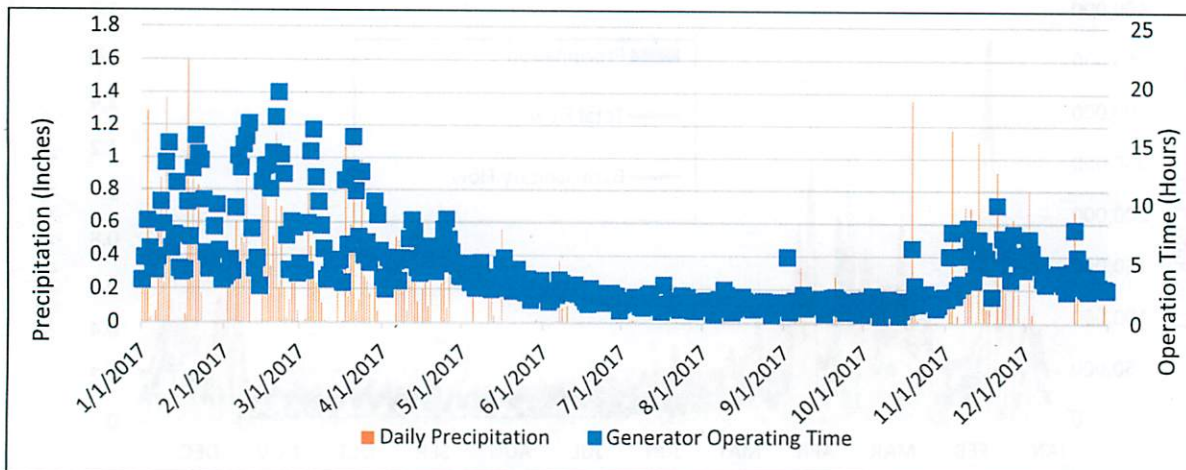
**Figure 13.** Lift station operation time over the course of 2017 (blue squares) and daily precipitation (orange bars).

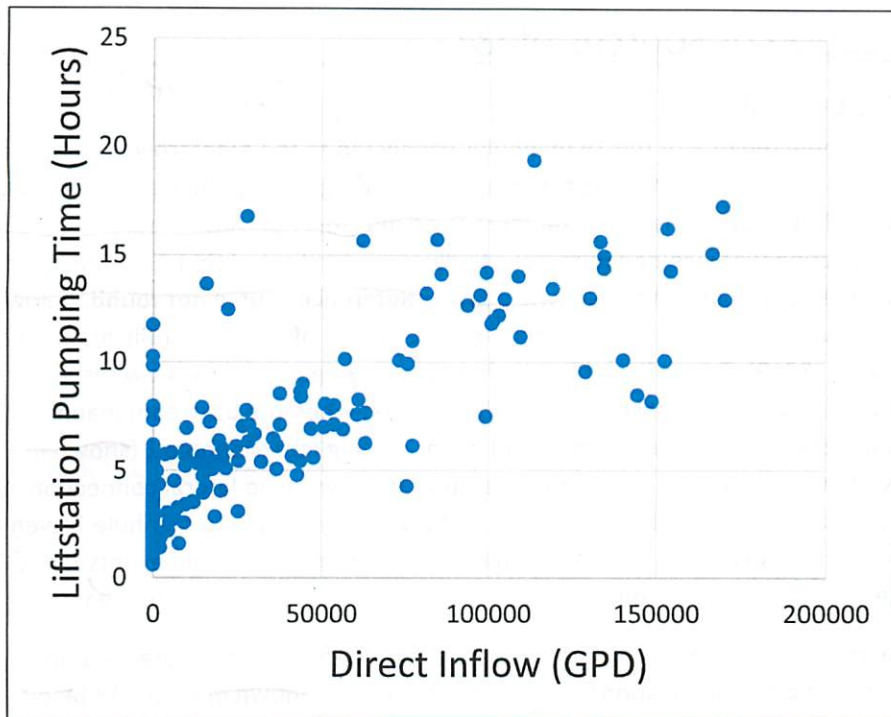
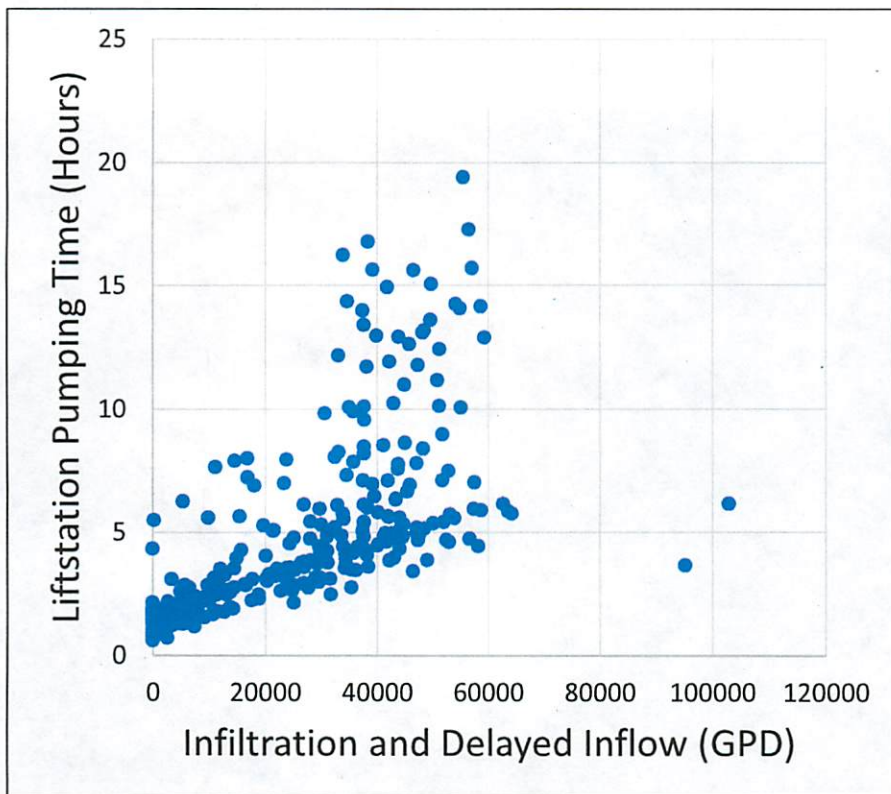
Figure 14. Lift station operation time (pumping hours) with respect to the daily volume of inflow and infiltration (bottom)

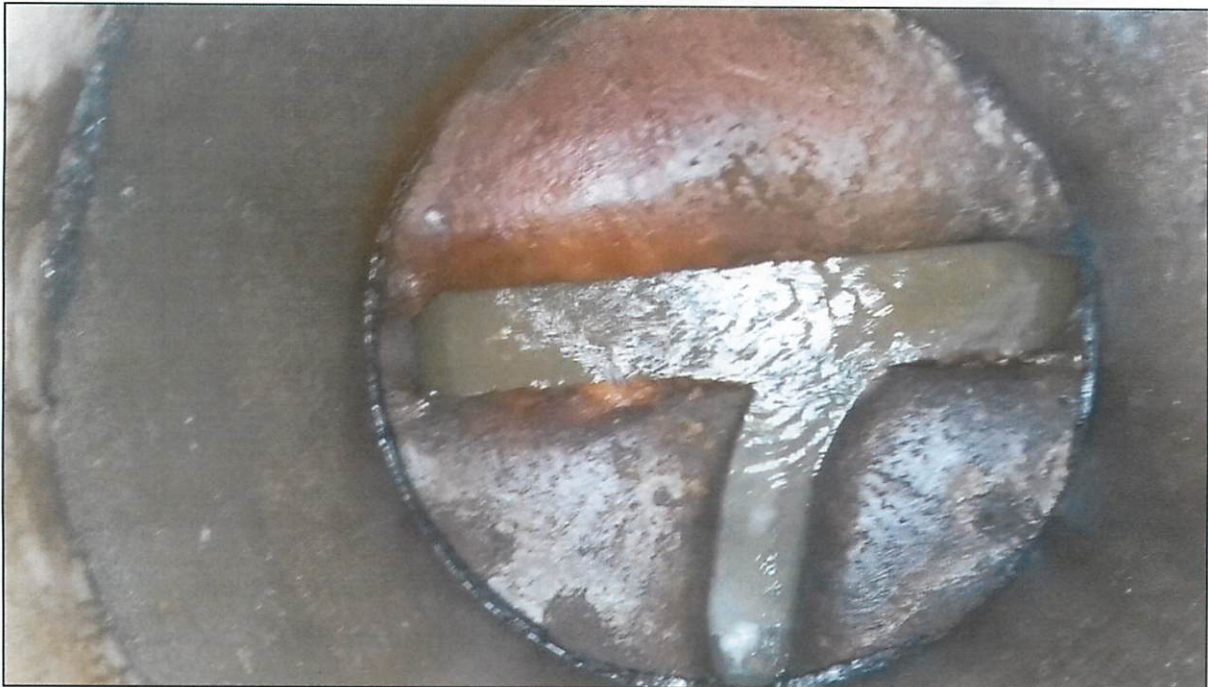
These manhole inspections also yielded discoveries of other defects, such as cracks, ponding water of manhole lids, effluent pipes, infiltration/seepage into manholes (shown in Figure 18 below), crumbling/crushed manhole walls or influent (shown in Figure 19 below). These defects contribute to infiltration into the sanitary sewer and were indicative that manhole rehabilitation is necessary. Photos reported in this section were taken by Jack Lisin.

**Figure 15.** Observed constant groundwater infiltration through crack in Manhole IP6.

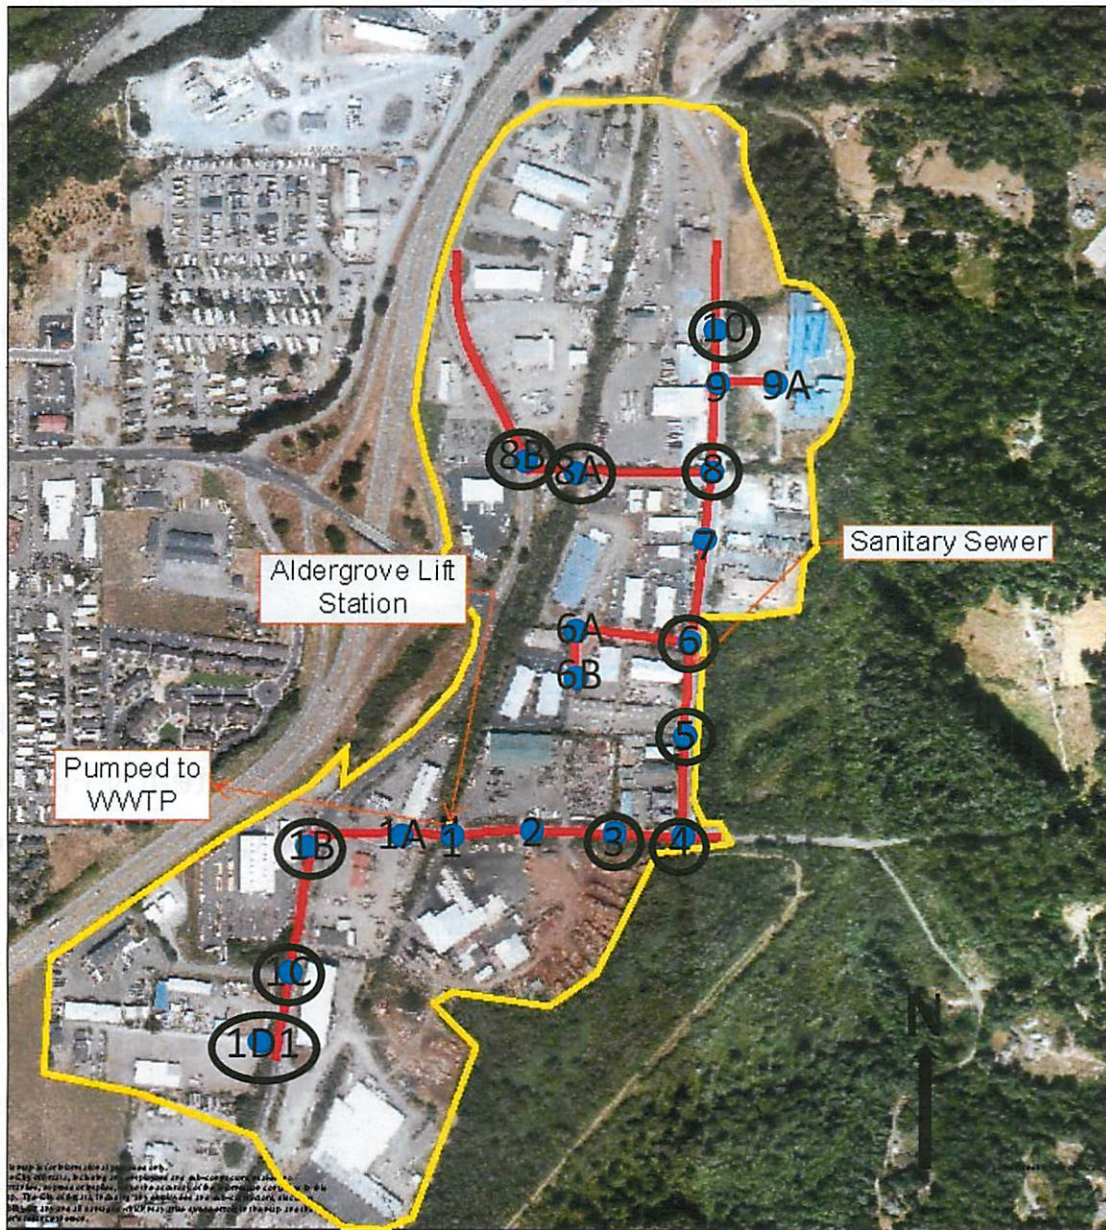
Inspection were conducted of 8 of the 19 manholes connected to the Aldergrove sanitary sewer. This involved opening the manhole, obtaining a depth invert, photographing the manhole, and looking for obvious defects and signs of infiltration (example shown in ~~Error! Reference source not found.~~). The results of this inspection work yielded numerous findings, and indicated that 11 of the 18 manholes inspected are in need of rehabilitation (shown in ~~Error! Reference source not found.~~ below). It was suspected that between manholes 1 and 2 there is some source of inflow or infiltration (Terry Barney, personal comments, 2019). To confirm this, Manhole 2 was pugged, and the flow response in Manhole 1 at the Aldergrove lift station was observed; this showed that when the upstream manhole (2) was plugged, there was still a considerable amount of water coming into Manhole 1 (shown in Figure 17 below). Review of CCTV inspection footage showed that there were no lateral connections between manholes, which indicates that the observed water that was still coming into manhole 1 even when 2 was plugged is likely infiltration or inflow. One possibility is that during heavy rain events Janes Creek raises and causes increases rates of either direct inflow or infiltration in the immediate area.

Figure 16. Manholes requiring rehabilitation as indicated from observations made when doing field inspections of them (City of Arcata 2019a).

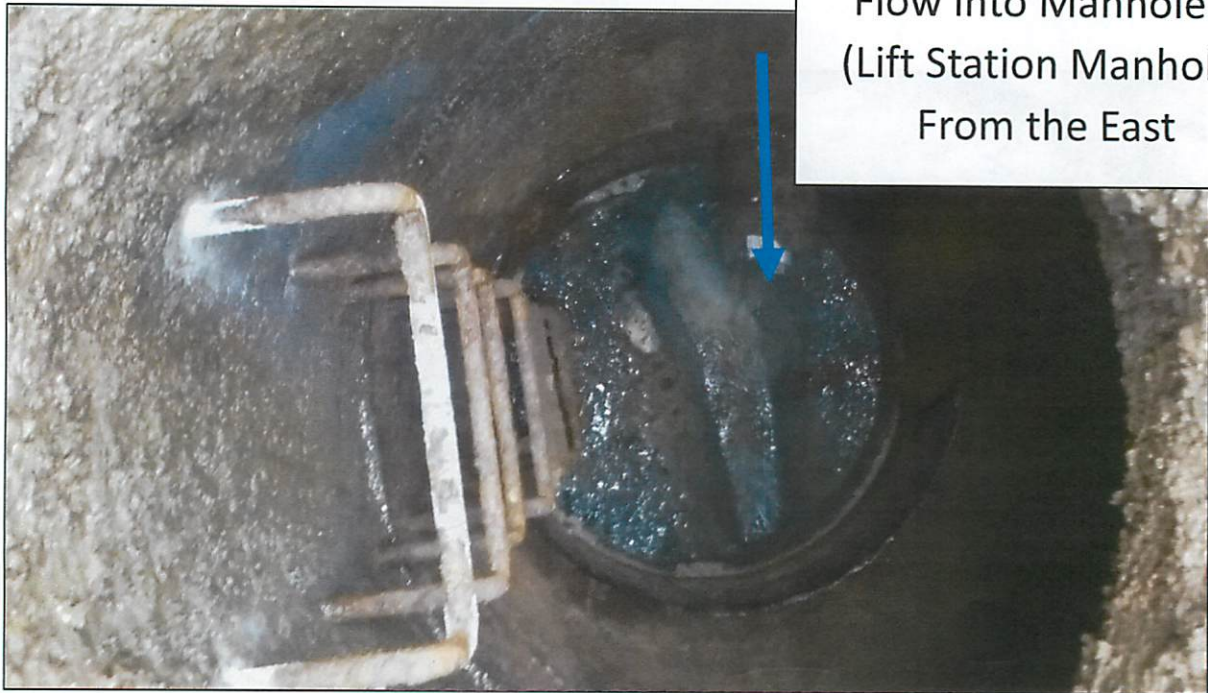
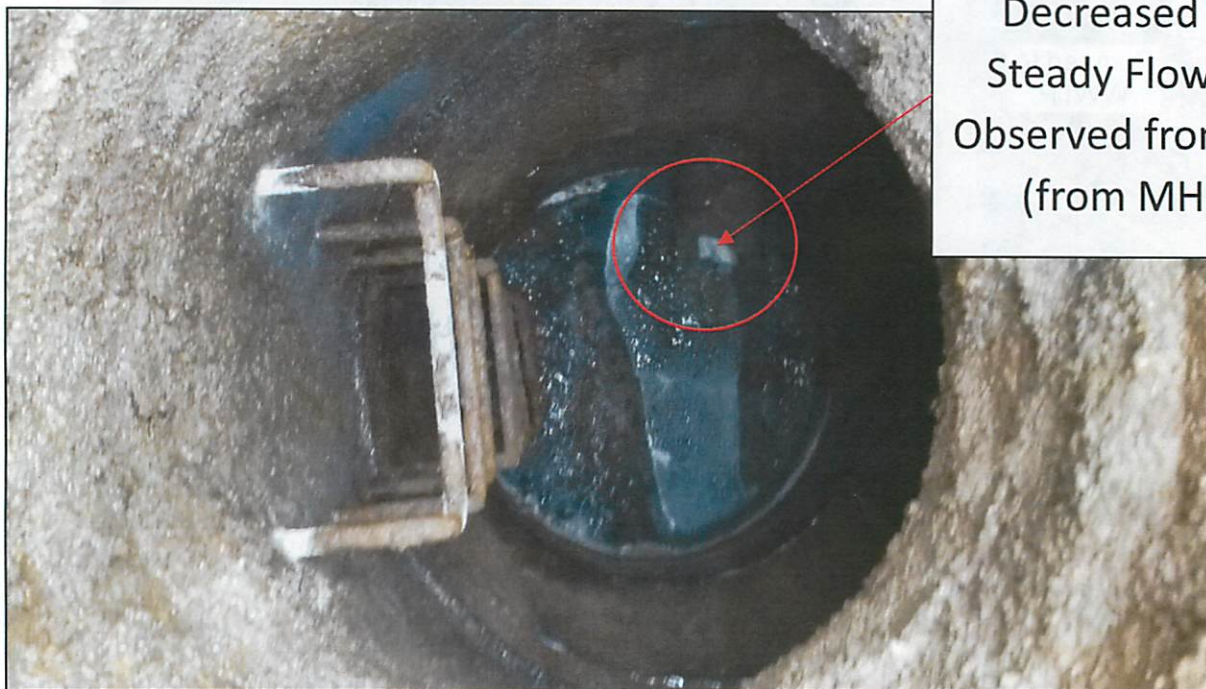
**Figure 17.** Observed flow response in Manhole IP1 (lift station manhole) when manhole 2 was not plugged (top), and when it was plugged (bottom). Shows that there was still significant flow coming from the pipe down stream of Manhole 2 even though flow into Manhole 2 was plugged.

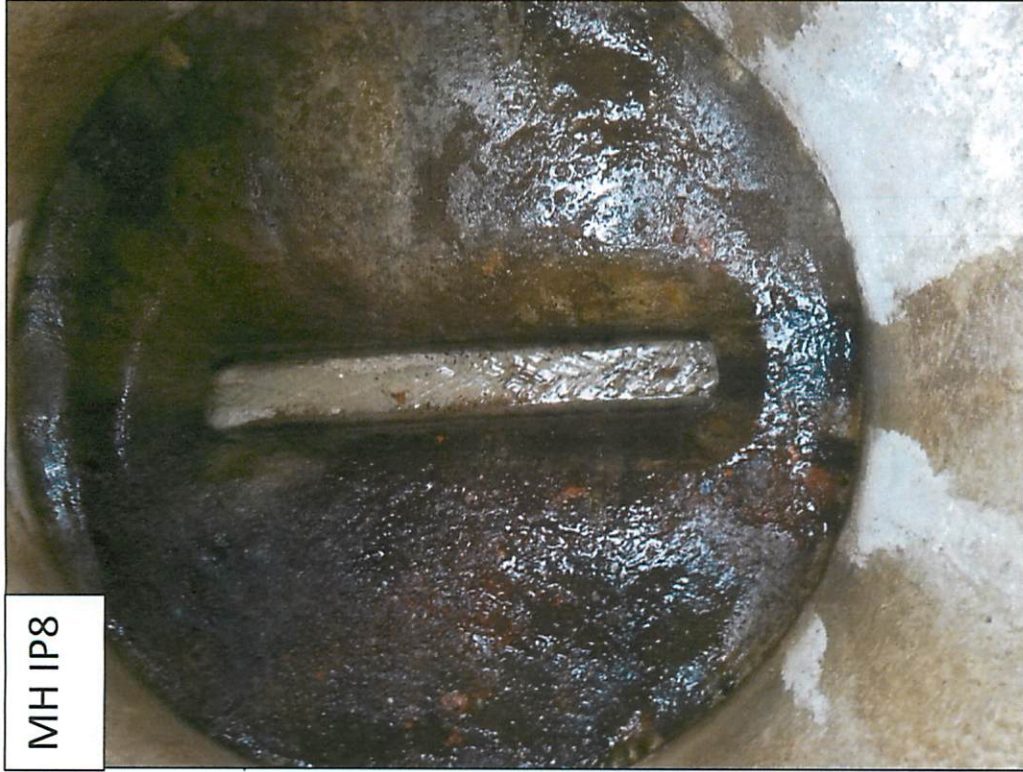
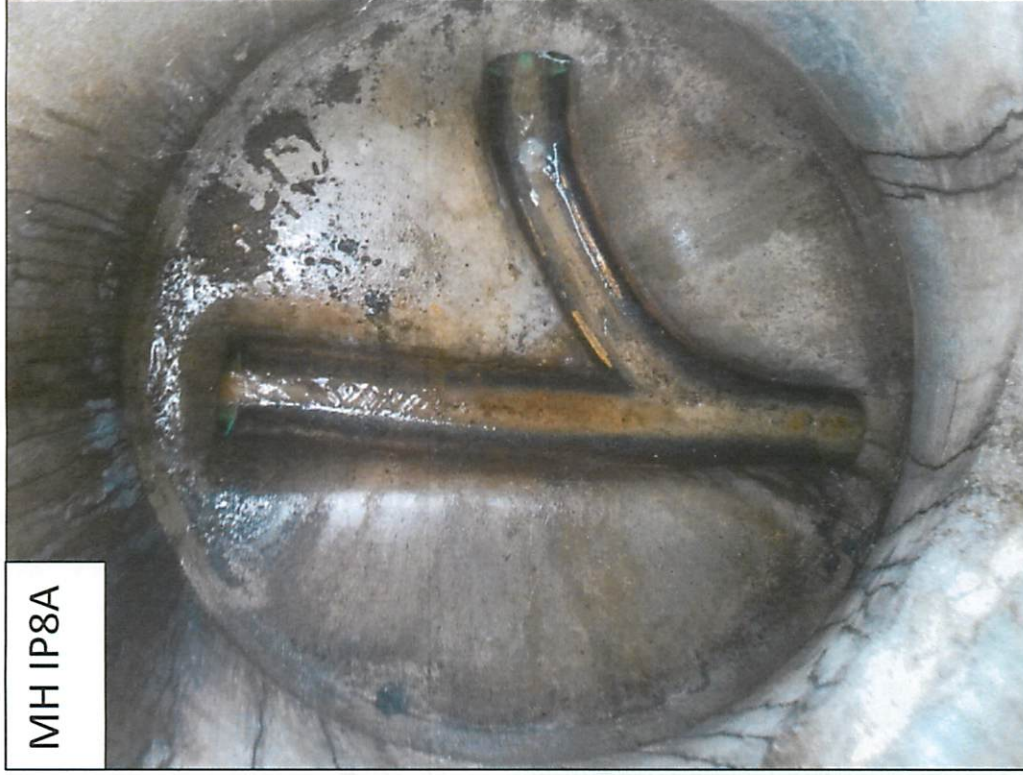
Figure 18. Sanitary sewer manholes connected to the Aldergrove sewer showing signs of infiltration.

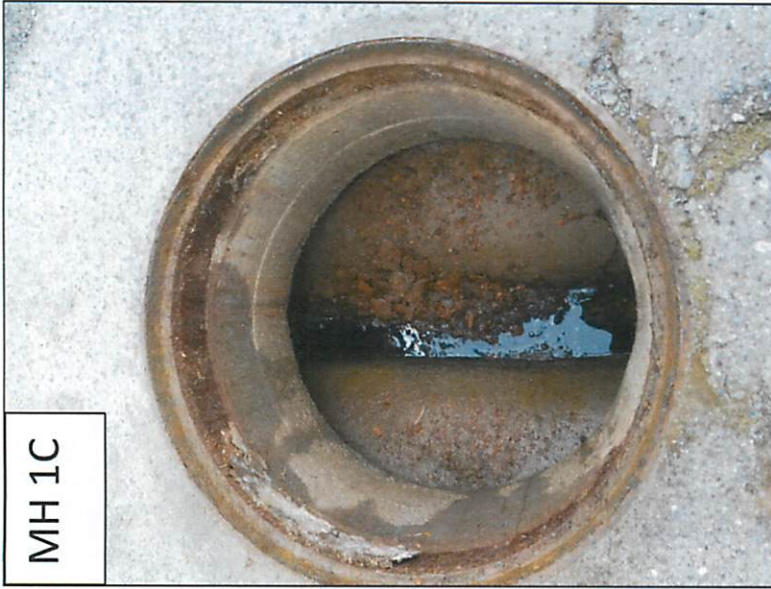
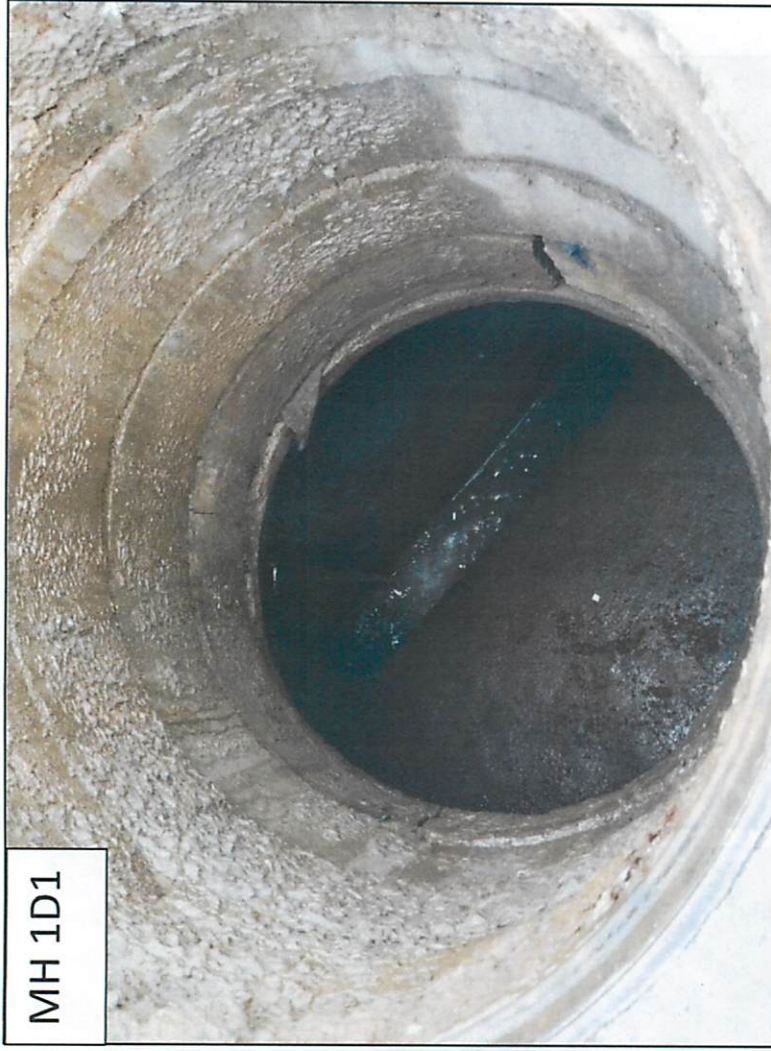
Figure 19. Sanitary sewer manholes connected to the Aldergrove sewer with defects (crushed vitrified clay pipe on left, crack and suspected inflow on the right).

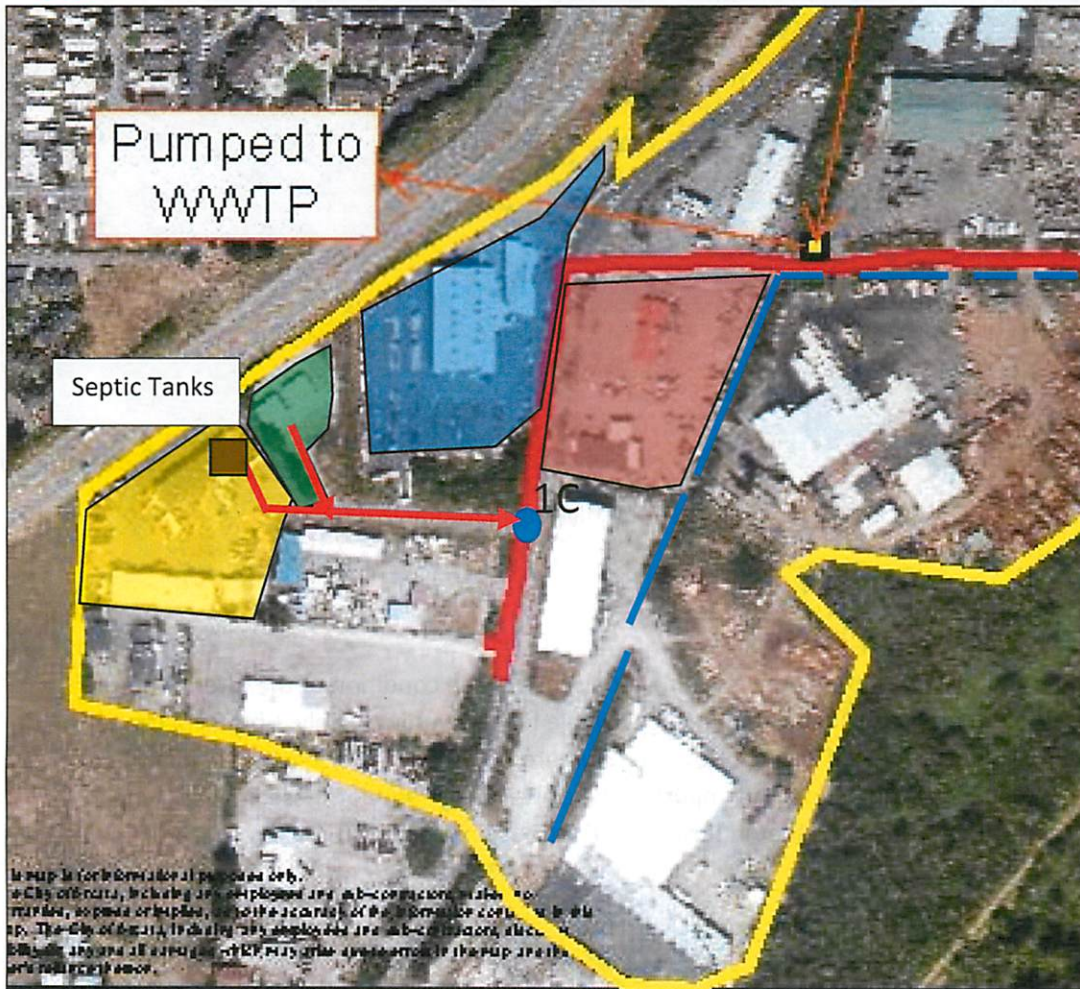
Five private property inspection (shown in Figure 20) were conducted in an attempt to identify and document sources of inflow and infiltration. The documented findings and developed inspection reports are to be shared with the City of Arcata but are not listed in this report due to time constraints. The manhole findings of this inspection work was that Janes creek frequently backs up on from the Mill yard which spills west over Janes creek into McCullough Constructions property (shown in Red in Figure 20). This is interesting because there is suspected infiltration into the sanitary sewer between manholes 1 and 2 in that area, it is possible that these two issues are related. The other significant finding was observed evidence of direct or delayed inflow of stormwater into the sanitary sewer. This was observed when inspecting manhole IP1C, as the system began surcharging after what is assumed to be a sump pump or septic tank pump kicked on (the flow rate approximately quadrupled in magnitude from a already steady flow from a lateral connection from the west into manhole 1C). The observed influent flow (shown in Figure 21) is fairly clear and is high in magnitude. From the property inspections it was determined that the parcel in green likely is not the cause of this high levels of flow because the have sinigang stormwater infrastructure.

Figure 20. Private property parcels inspected during the inflow identification survey.

Two septic tanks on the parcel in yellow (Figure 20) were found to intercept wastewater from the property prior to it being pumped to the sanitary sewer. It is expected that the source of the suspect inflow could be into those septic tanks, where the pump is activated by a float switch valve, which would trigger a response if extraneous stormwater is entering the pipe. When the footage shown in Figure 21 was obtained it was fairly wet out. Additionally, the same phenomena were observed a few weeks later when it was a lot drier, and the pump kicked on again, except the observed flow was much lower. This is taken as evidence of direct inflow into the sanitary sewer from private property, which is important to consider with respect to the developed design alternatives (in Section 7 below).

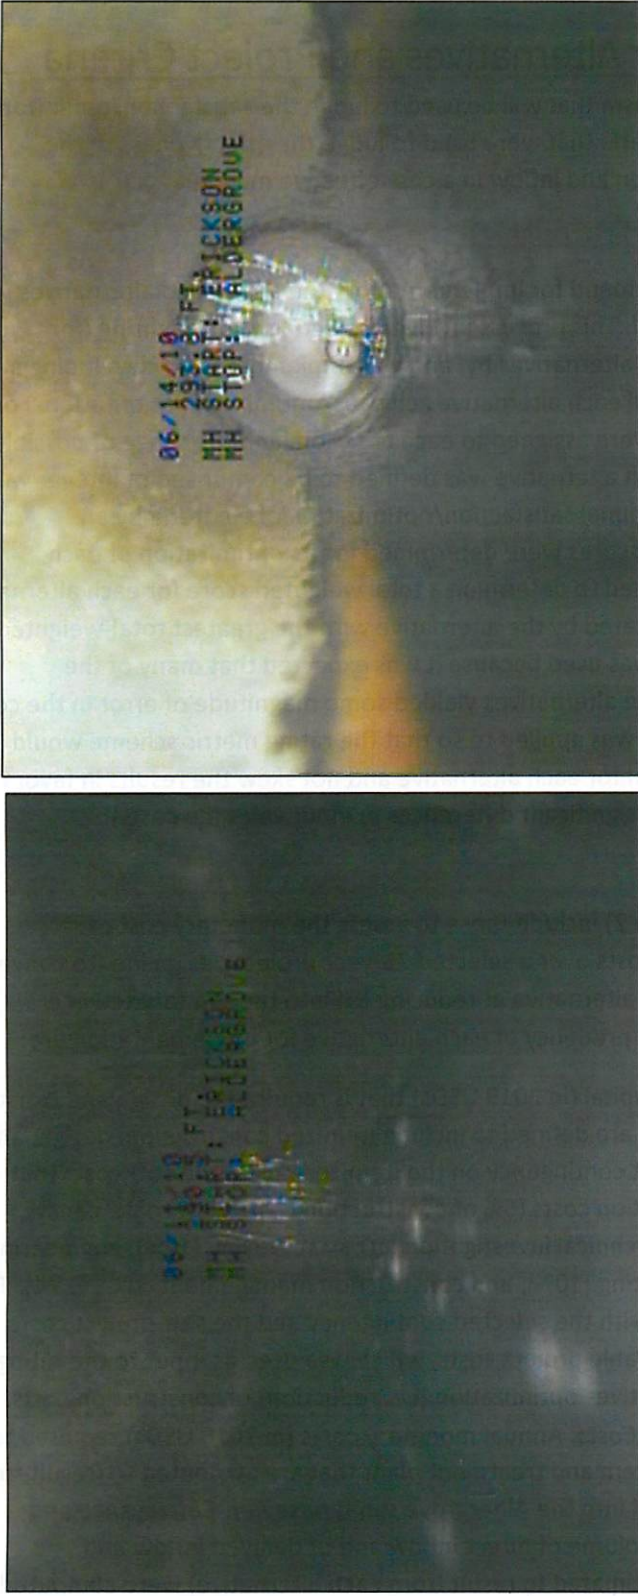
CCTV footage from 2010 was briefly reviewed to get a sense of the condition of the interior of sanitary sewer pipes. While there was roughly 6-hours of available footage, only roughly 2-hours of it was reviewed due to project time constraints. However, numerous cases of infiltration were identified (examples shown in Figure 22 below). An important take away is the date of these images (June in 2010). This lends to the conclusion that infiltration is a serious problem, as it is likely much worse in the wintertime.

Figure 22. CCTV inspection footage of infiltration into pipes in the Aldergrove sanitary sewer during an inspection in June 2010.

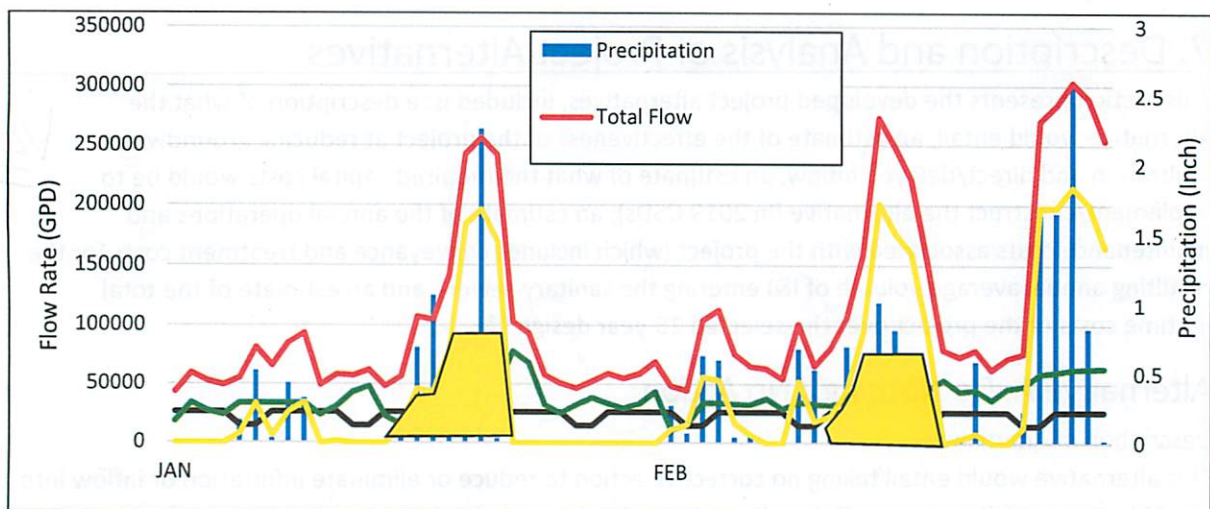
**Figure 23.** 2019 flowrate profile for the Aldergrove lift station. The volumes of direct inflow filled in yellow is approximately equal to the required volume of the equalization basin to dampen down the peak flowrates by approximately 50%.

Using the developed algorithm to separate inflow and infiltration from total daily flow rate observations (given the base sanitary flowrate), the impact of adding an equalization basin was assessed. Data for the year of 2018 was taken as a model case. Modeling the impact of the basin was achieved by distributing the volume of direct inflow that occurred during heavy precipitation events over subsequent days after the precipitation ends—this model the storage of direct inflow. This analysis indicated that an equalization basin would decrease the annual O/M costs by roughly \$5,000 (2019 USDs).

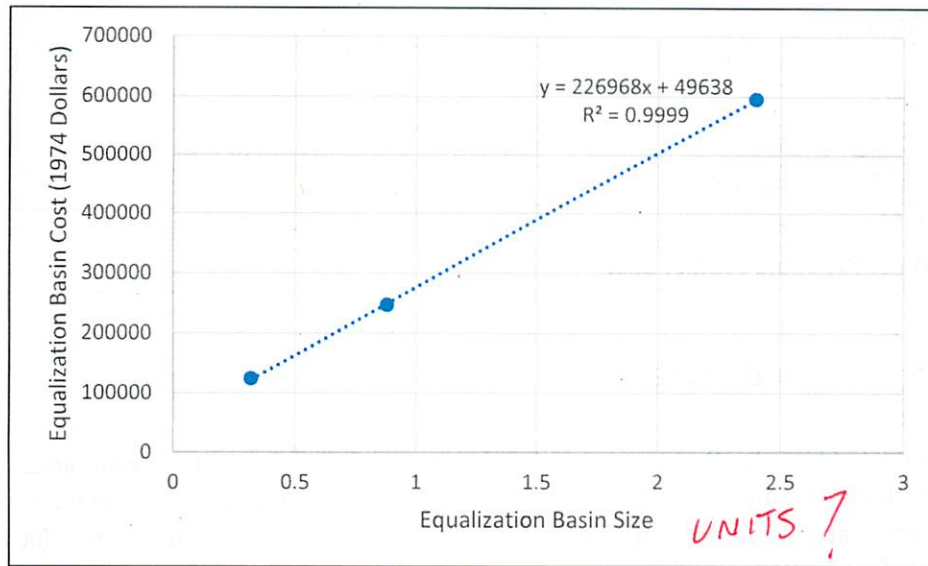
Figure 24. Equalization basin size and corresponding cost data (EPA 1974).

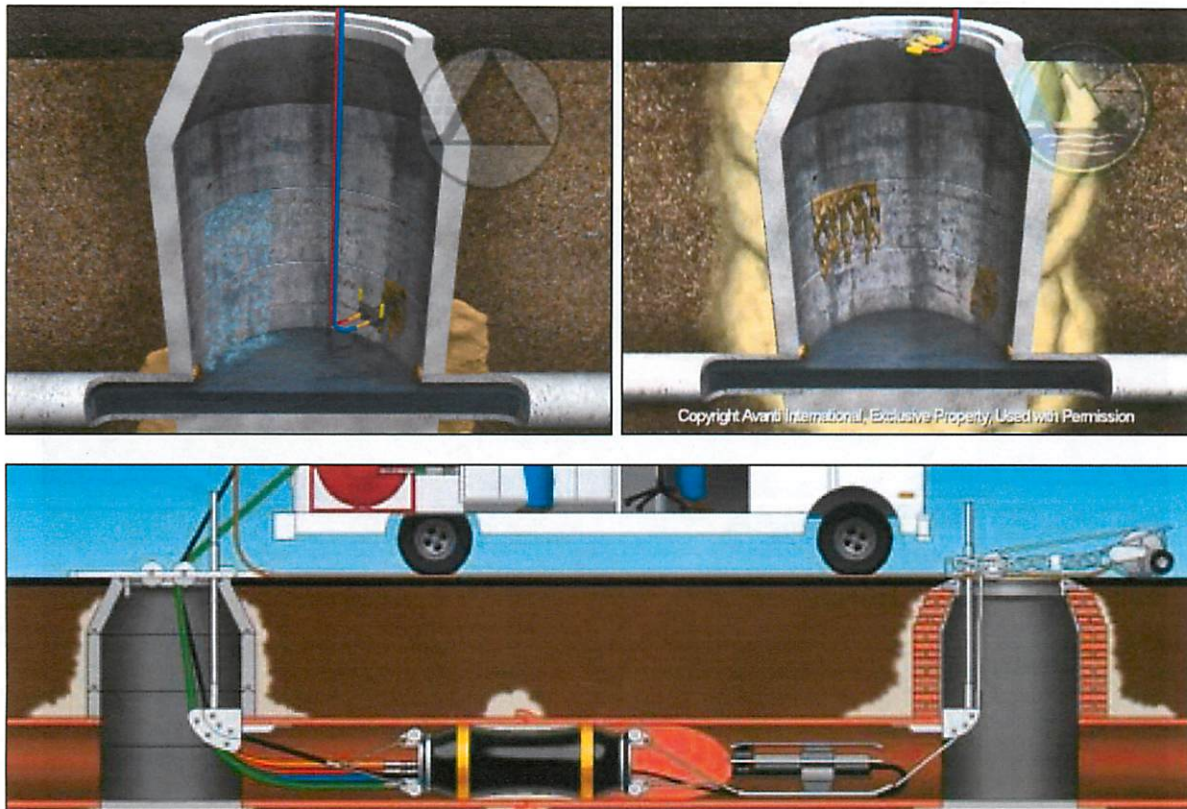
**Figure 25.** Conceptual overview of the chemical grouting process for manhole rehabilitation (top) and sanitary sewer main line rehabilitation (bottom) (Amazon 2019) (BlueBook 2019).

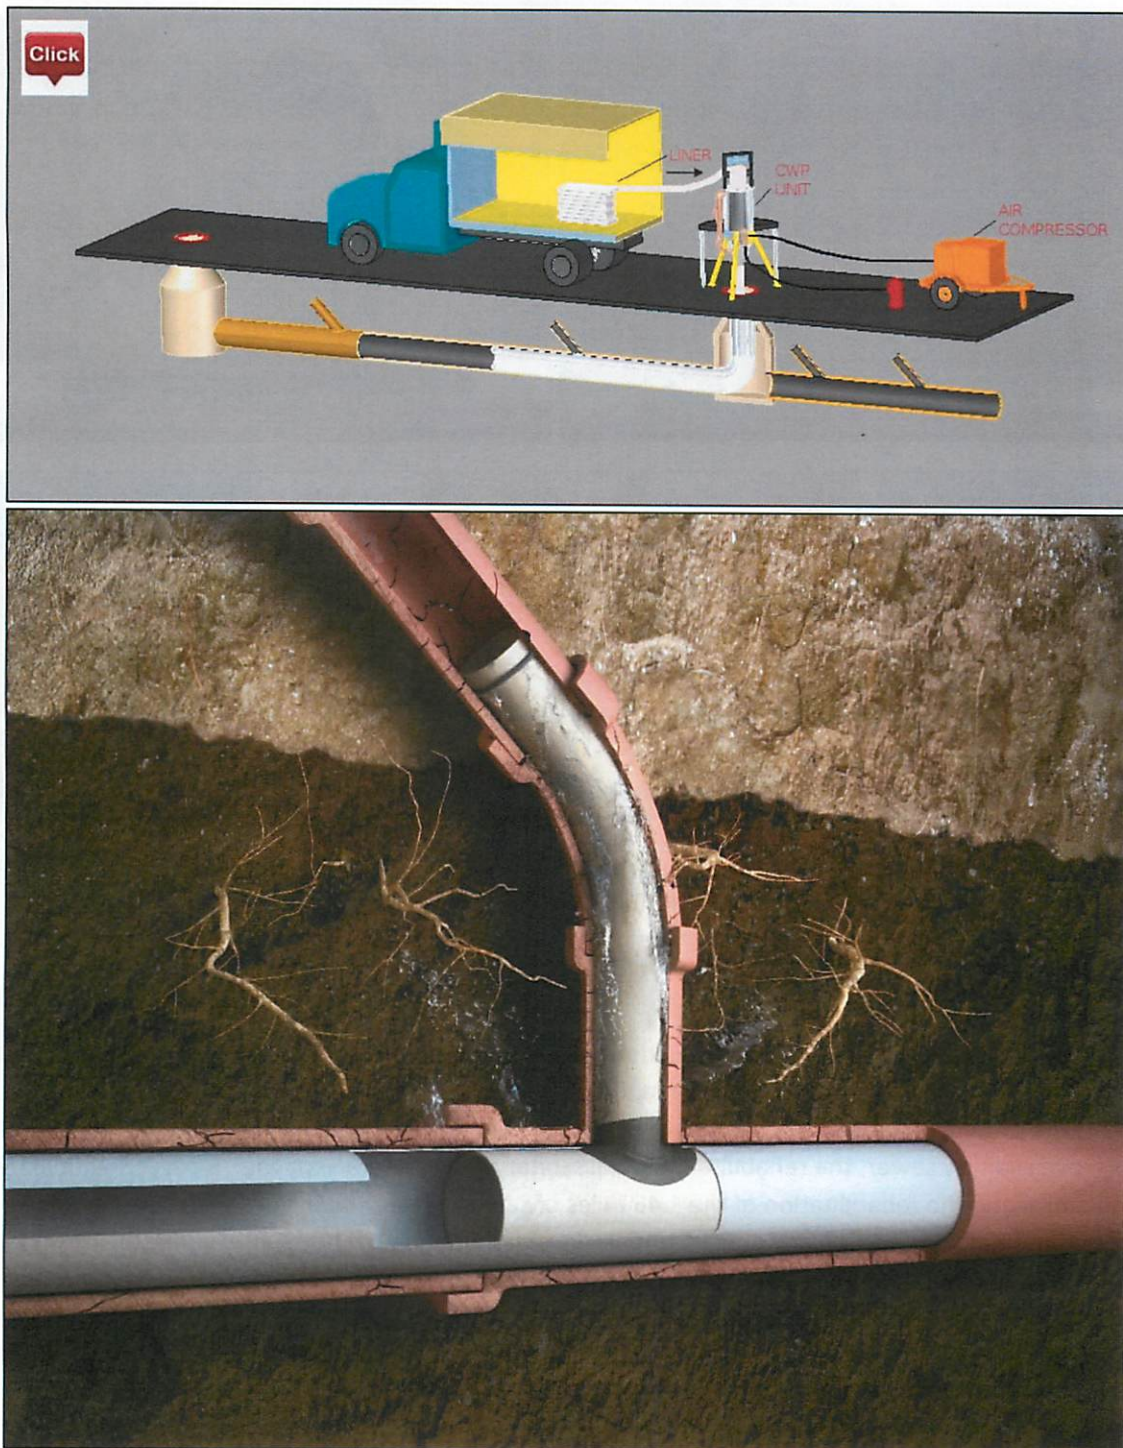
Figure 26. Schematic of the process of lining sanitary sewer pipe lines with cured-in-place pipe (CoA 2019b).

This alternative would be an infiltration reduction project that would also serve to restore the structural integrity and functionality of rehabilitated manholes, sanitary sewer main lines, and sanitary sewer laterals; the project would involve the rehabilitation of 11 of the 19 manholes connected to the Aldergrove sanitary sewer, the rehabilitation of all sanitary sewer laterals for the 76 parcels with active connections, and the rehabilitation of the 1.46 miles of sanitary sewer main lines with cure-in-place pipe-within-a-pipe. Cured-in-place pipe essentially involves inflating a fabric sock that has been impregnated with an epoxy resin that is inflated and expanded along the interior of the sanitary sewer pipes and which is heat cured to harden in place (process shown in Figure 26). The result is some structural rehabilitation and sealing off of the sewer pipe. Sanitary sewer laterals would be rehabilitated using T liners that protrude up into sanitary sewer laterals, sealing the connections and preventing infiltrations/seepage through the joint, as well as providing structural rehabilitation and infiltrations reduction for the lower lateral (CoA 2019b).

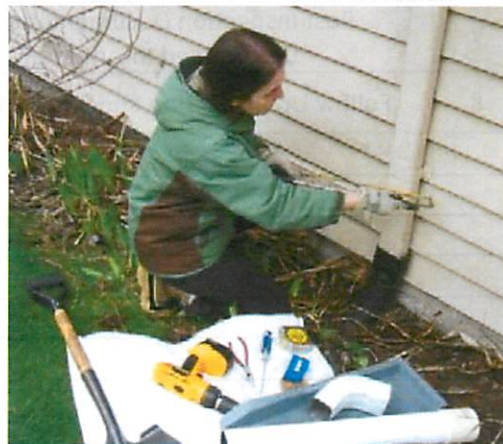
**Figure 27.** Photo of an Arcata resident disconnecting a storm drain that was connected to the sanitary sewer (CoA 2019e).

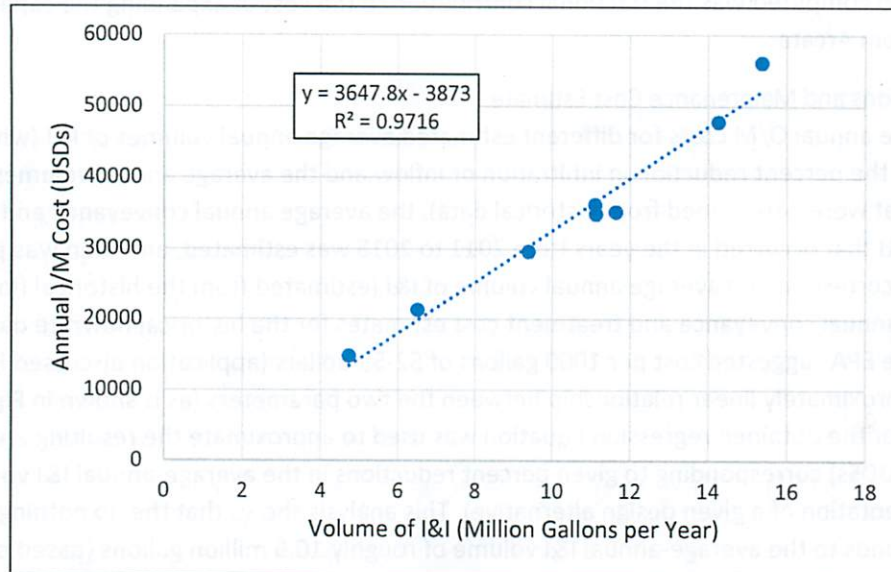
**Figure 28.** Total annual O/M costs with respect to average-annual volume of infiltration and inflow (volumes lumped together). Developed from historical total-daily flowrate data for the Aldergrove lift station from 2011-2018. Monetary O/M costs in 2019 US dollars.
