# 2019 Aldergrove Sanitary Sewer Infiltration and Inflow Reduction Project

ENGR 481, Spring 2019

2019 Aldergrove Sanitary Sewer Infiltration  
and Inflow Reduction Project  
Final Report

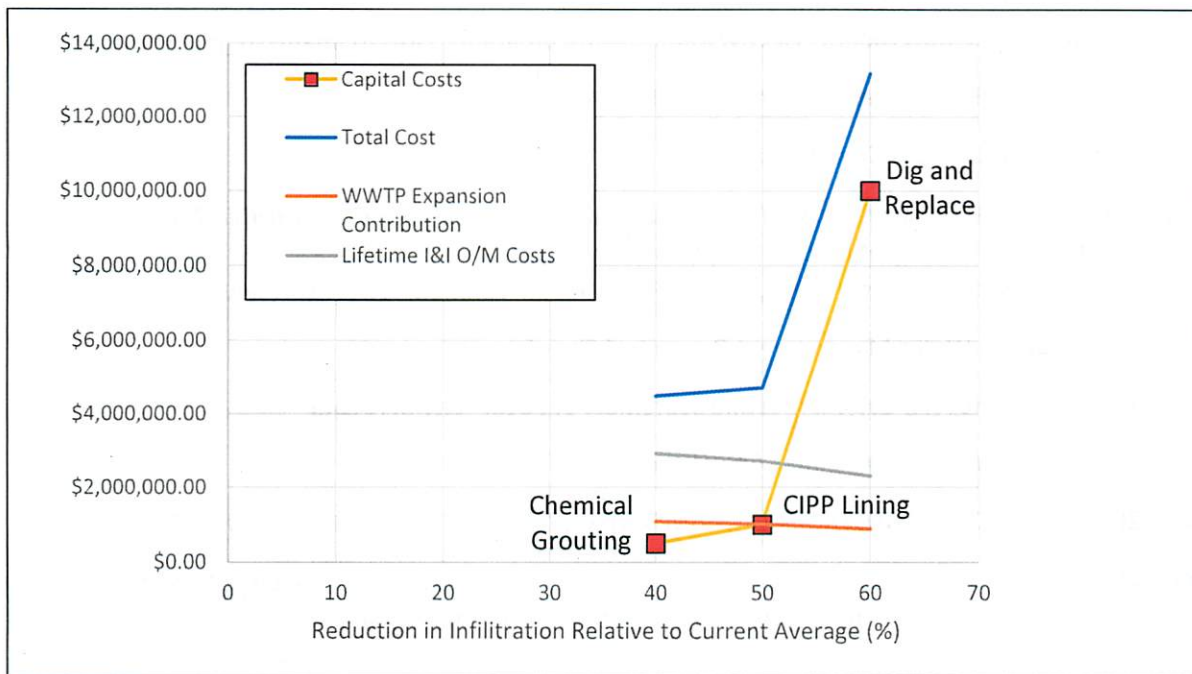
Figure 29. Cost curves for the different components of alternative costs for the three stated sanitary sewer main line infiltration reduction alternatives.

It is recommended that the City implements the winning alternative of the Delphi method, Alternative G: Direct Inflow Reduction, because of the combination of its low capital costs, low resulting O/M costs, and low lifetime costs. However, in consideration of the ongoing 2018 City of Arcata Sanitary Sewer Infiltration Reduction project, and the potential for decreased legal, mobilization, and other project costs, it is also recommended that the City implements alternative E: CIPP lining. While the required capital cost of lining makes the alternative less attractive over the 25-year lifetime then the direct inflow reduction alternative (as shown in Figure 1), the fact that it would rehabilitate the structural integrity of the sewer and likely extended its lifetime makes it an attractive alternative. Because the City is currently involved in a large scale CIPP lining project, it may be prudent for the City to seek lining of the Aldergrove sanitary sewer during or immediately <sup>AFTER</sup> the construction/implementation of the 2018 infiltration reduction project, as the capital costs may be cheaper at that time then others (since the contractors are already mobilized in the City).

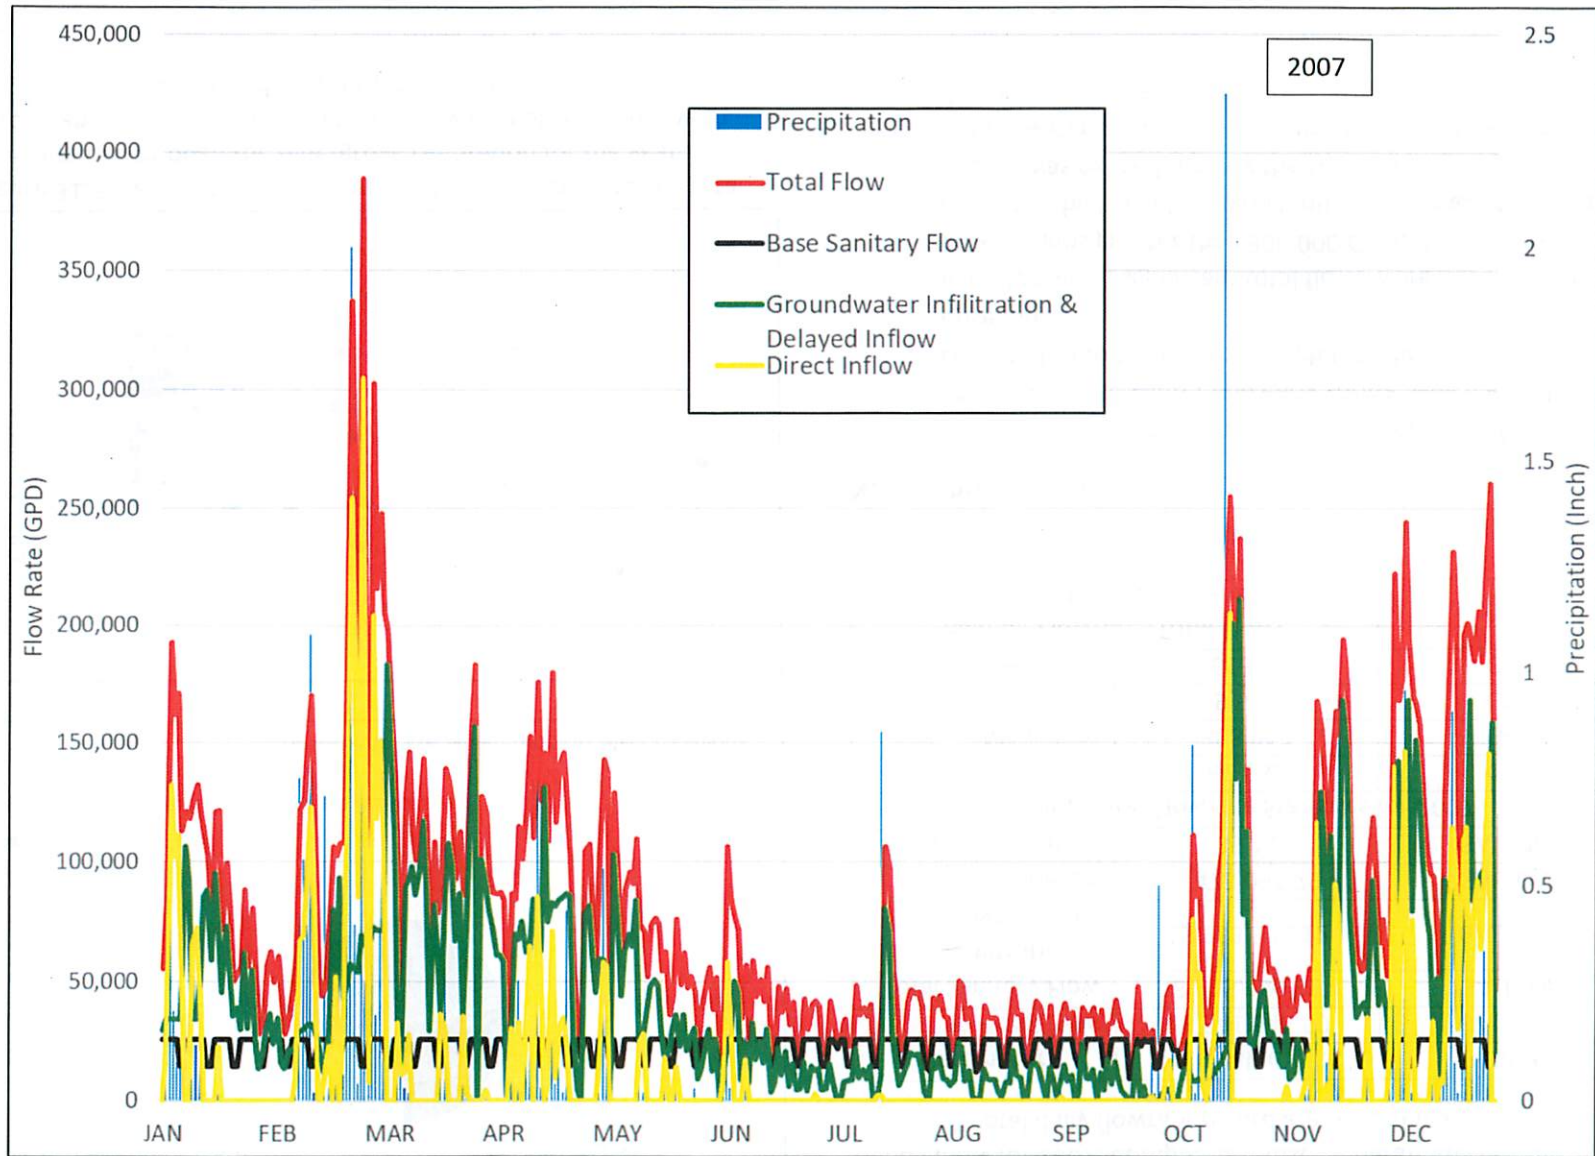
Figure 30. Aldergrove lift station flowrate profile for 2007

- Significant rates of infiltration and/or delayed inflow occurred in late winter and early spring, which greatly contributed to the observed high total flowrate observations.
- In early march, significant total flows were observed (three observations greater than 300,000 GPD). These were caused by high levels of direct inflow; the magnitude of the impact was exacerbated by the simultaneous high groundwater infiltration rate (which was approximately 75,000 GPD at that time).

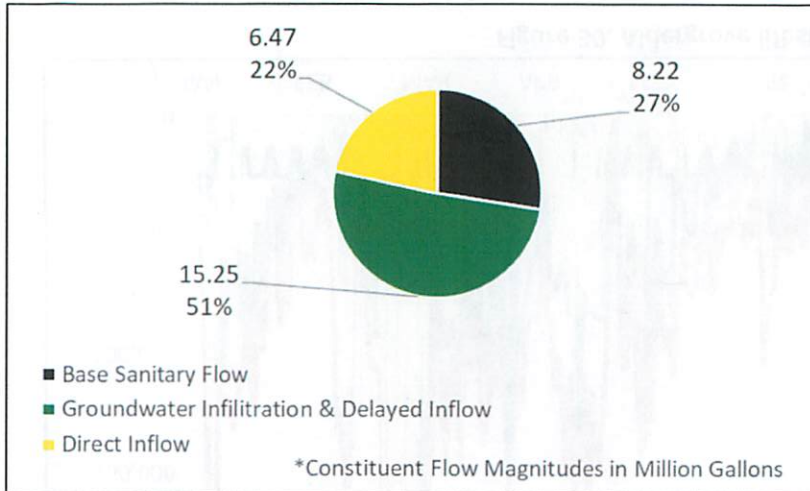
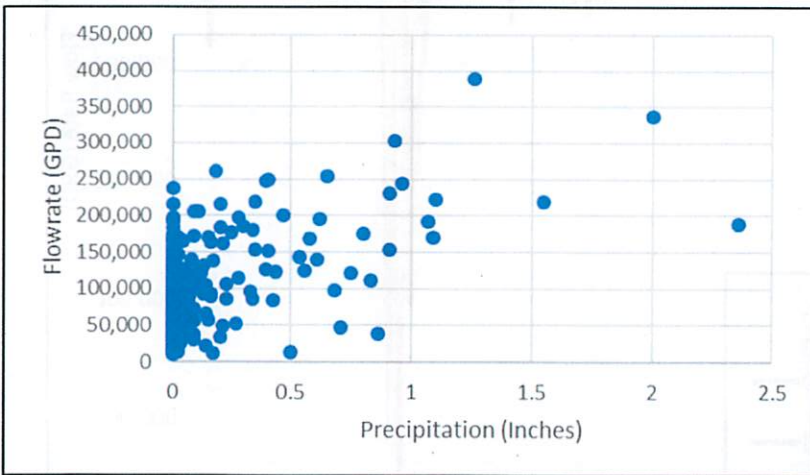
Figure 31. Flow contributions from constituent sources to the total flow pumped through the Aldergrove Lift Station for the year 2007 (top), and a scatter plot of total daily flowrate observations with respect to daily precipitation (bottom).
